**AN ARCHAEOLOGY OF EARLY ENGLISH BOATBUILDING
PRACTICE c. 900-1600 AD:**

Based mainly on finds from SE England

VOLUME 1. TEXT

For a PhD in Archaeology at the Dept. of Medieval Archaeology, Institute of Archaeology,
UCL London.

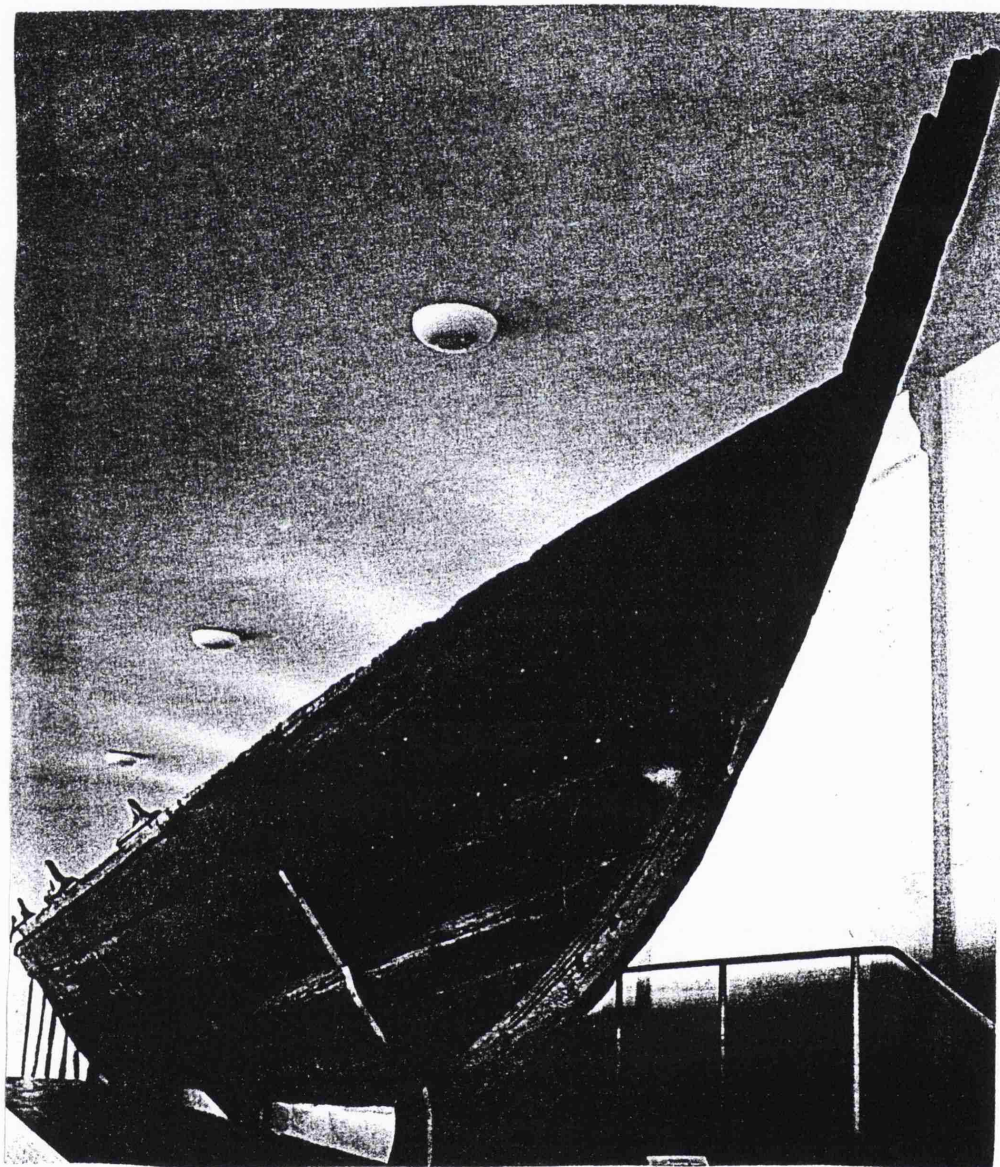
Fig. 7 The Nydam boat as restored, photo.

The near complete 'oak boat' was the best preserved find (fig.7), though parts of another oak boat and some timbers of a softwood vessel were also found. The oak boat was so well preserved that a physical reconstruction was carried out and comprehensive detailed drawings made of it. The vessel was about 23.5m long with a beam of 3.05m, though the reconstructed beam and freeboard is much debated (Rieck and Crumlin-Pedersen 1988:116). Most of the strakes of the hull were thought to have been in one piece and therefore exceptionally long boards. However, it is still possible to see in the restored vessel that in some strakes the angle of emergent knots, once branches (tilted slightly upward. in oak) reverses indicating the scarfing of at least two separate boards for those strakes. The laps were fastened with iron rivets or 'rove nails'. The naturally grown, single piece frame timbers were lashed to cleats left up-standing on the insides of the hull boards. The keel was very wide and shallow.

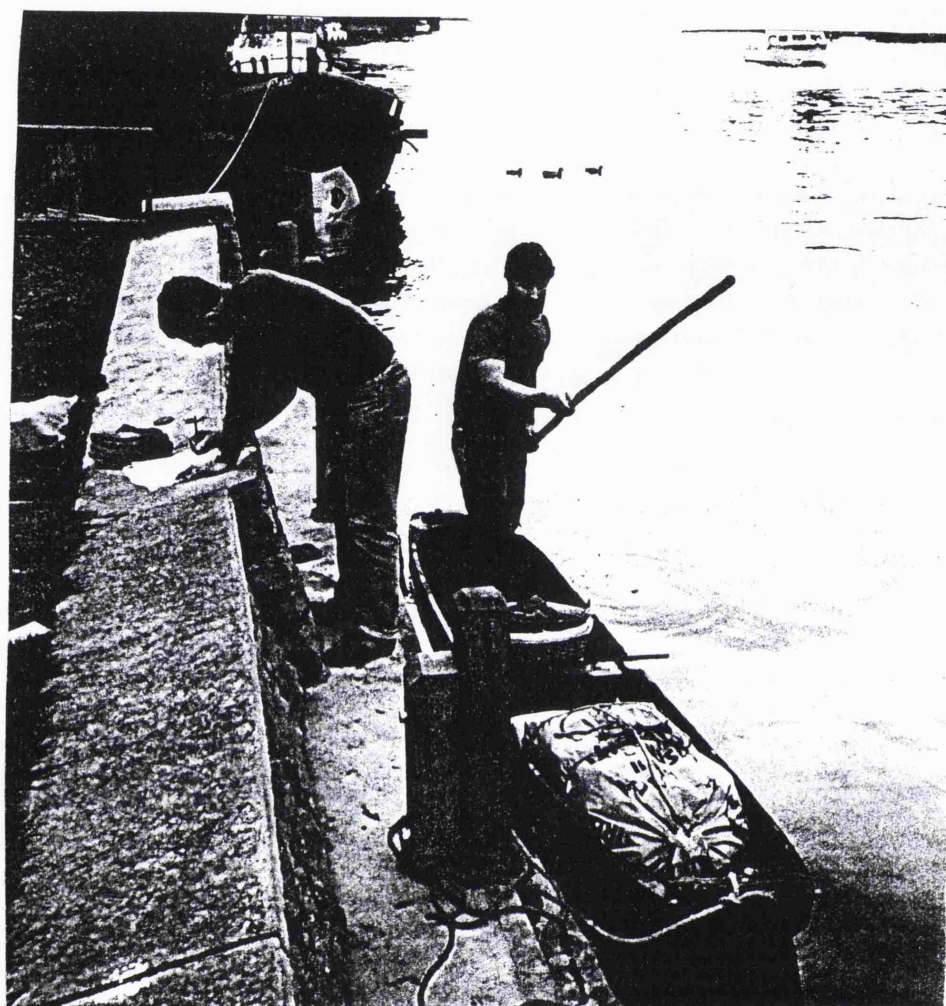
Fig. 41 The replica of the Clapton boat undergoing loading trials with, peat, firewood and salt as cargo on the punt racing course, at Taplow on the R. Thames. (Photo. V.Fenwick).

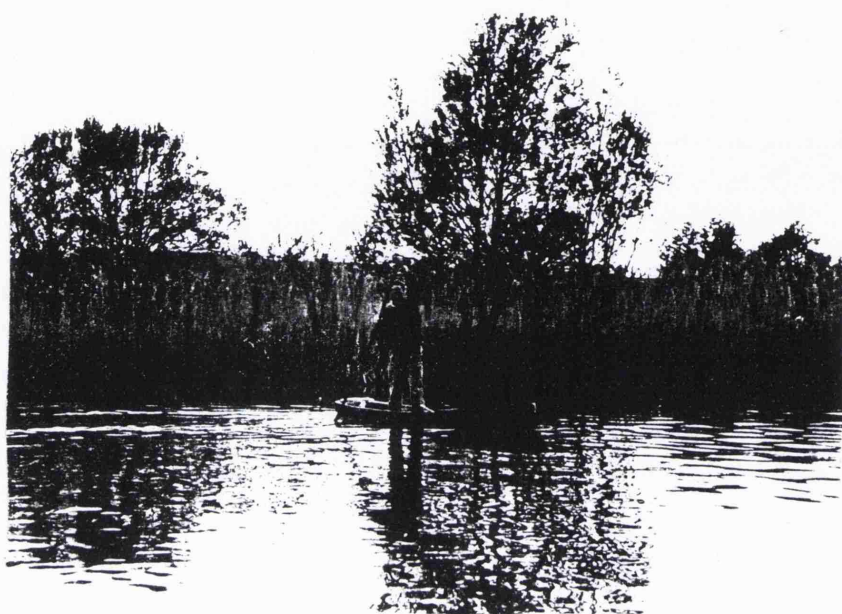
Fig. 42 Punting the replica of the Clapton dugout boat at Llyn Langorse, Wales. (Photo author).

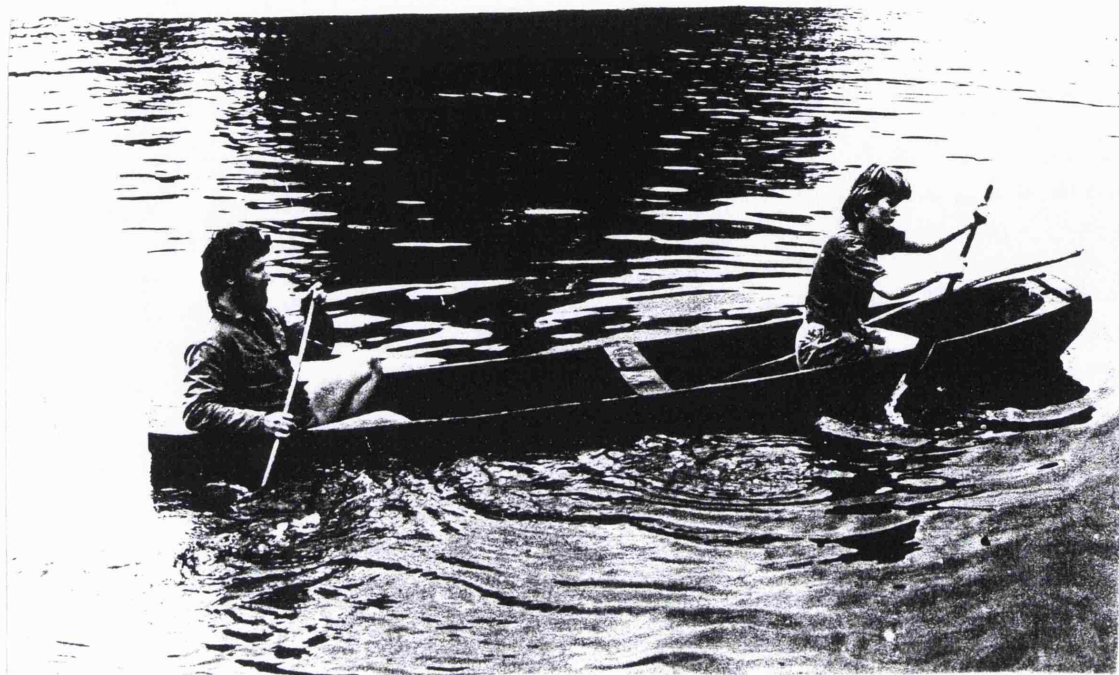
Fig. 43 Paddling the Ravensbourne Clapton Dugout boat replica through power boat wash (equivalent to small estuary waves), with 2 adults, Taplow on Thames. (Photo V. Fenwick).

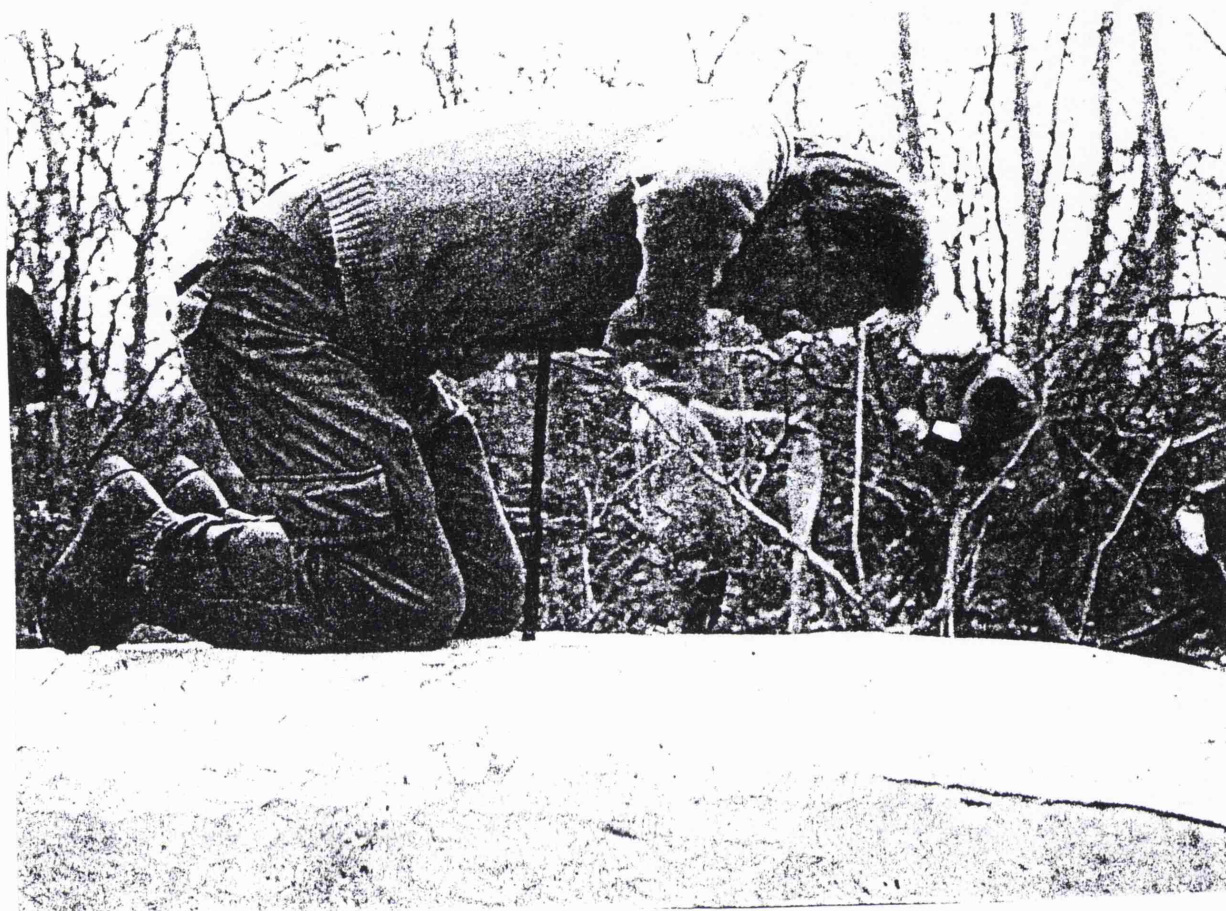
Fig. 49 Boring a thickness gauge hole through the inverted bottom of the Clapton dugout reconstruction. (Photo author).

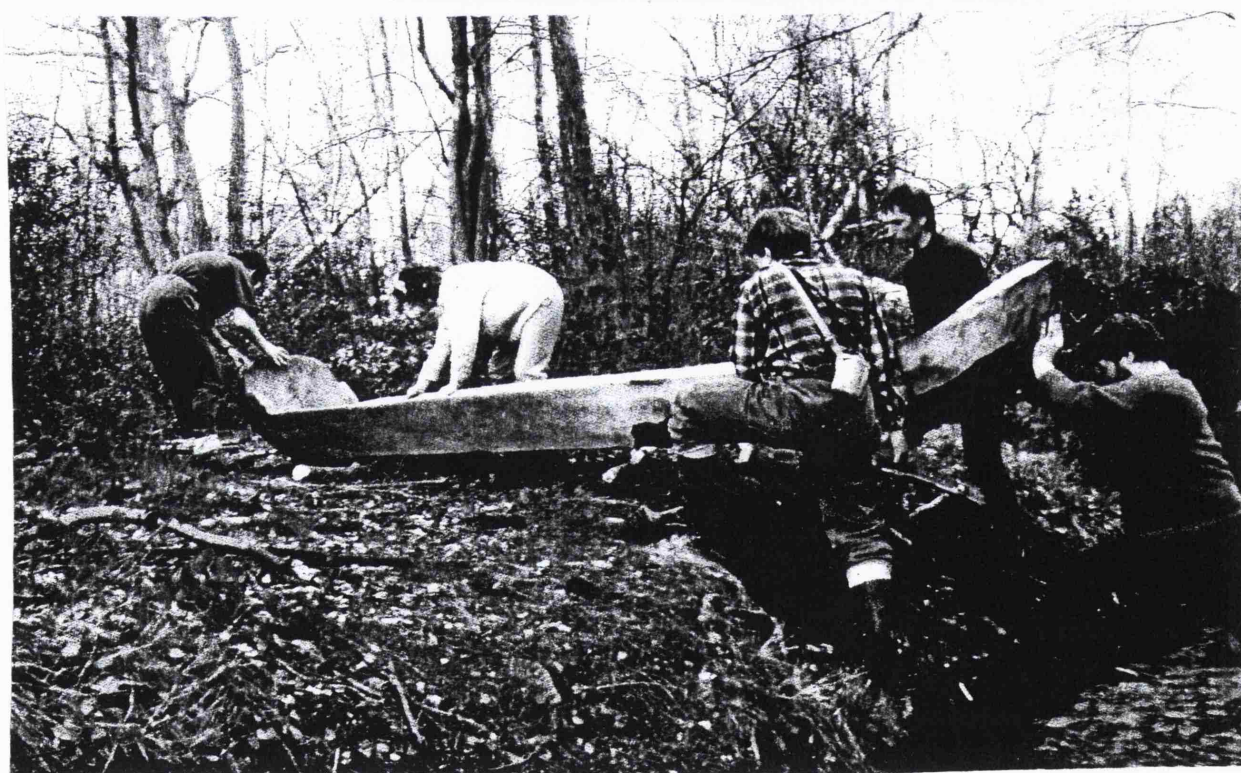
Fig. 64 Extracting the experimental Kentmere 1 boat replica dugout base. A) About 90% finished Barnet wood, London. (Photo author). B) 4-5 adults moving the green bottom section along a woodland path and over a small stream using branches as skids. (Photo. C. Milne.).

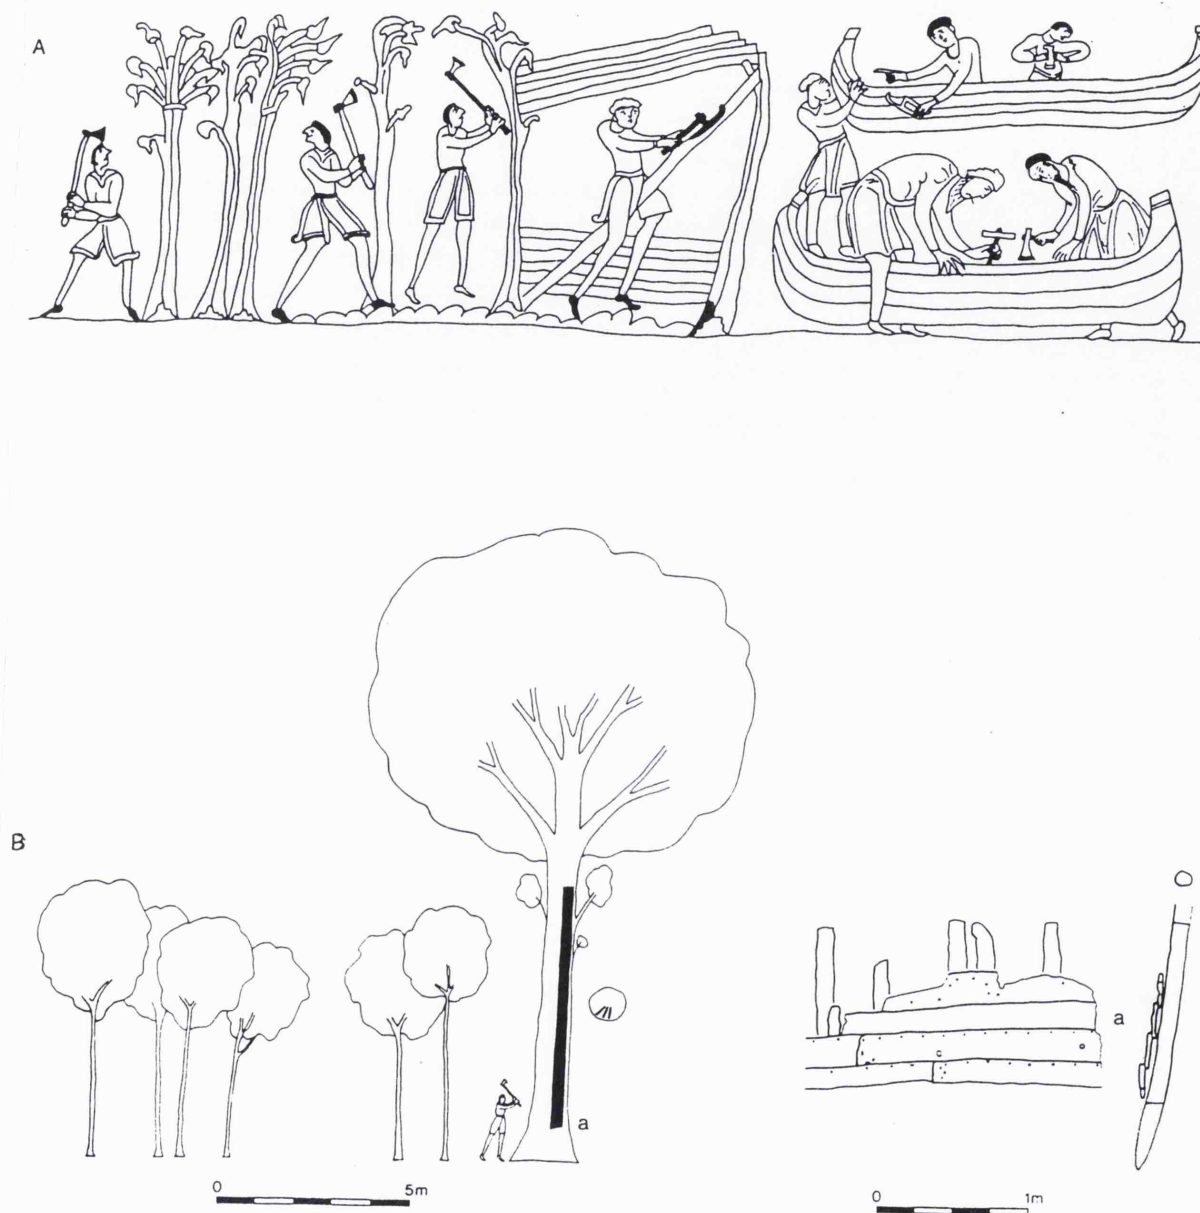
Fig. 81 The Bayeux Tapestry shipbuilding scene, and reconstructed early medieval wildwood 'board' trees. A) A scene from the Bayeux Tapestry showing tree felling, board hewing and building clinker ships. Not included are the essential stages of cleaving the ship board. B) A reconstruction of a typical early medieval wildwood oak suitable for making contemporary ship boards, as shown reused in a late 10th century river wall from London, TEX88 (after Goodburn 1992, Fig. 105).

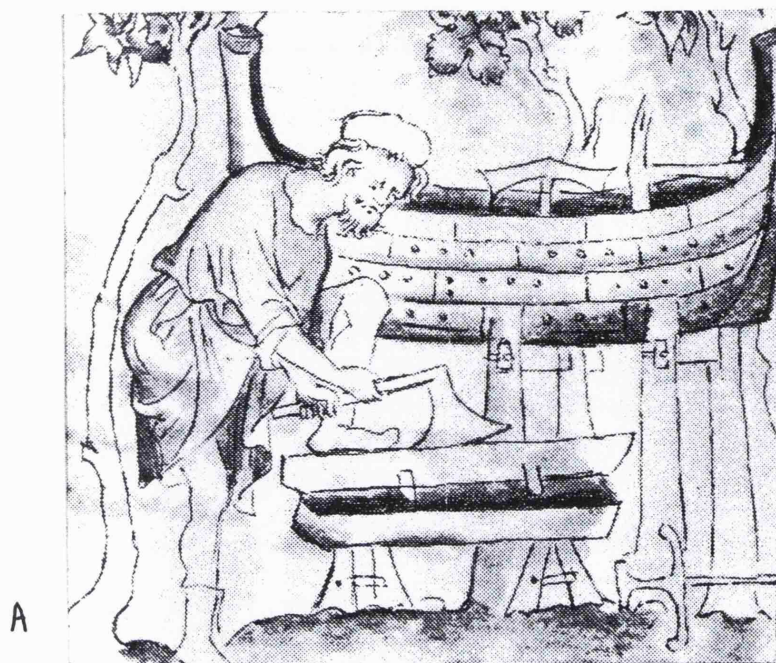
Fig. 91 Two representations of clinker boatbuilding. A) Ark building, c. 1315, English (after Harvey 1975, Fig.43). Shipwright appears to be hewing a short hood end board to shape, note the great number of scarfed short boards shown in the strakes of the vessel behind. B) Detail, in Dutch painting by the Master of Gouda, c.1565, (after Friel 1995, Fig. 3.3). Appears to show the building of a small vessel out of short cleft boards. Note the multiplicity of shores, and temporary cleats, the 'clencher and holder' on the port side and the 'shipwright' to starboard.

3) Along side the above, the boarders ('berders') would presumably have been hewing the rough cleft boards reasonably smooth and to the cross section required by the master shipwrights (figs.80c.and 91a).

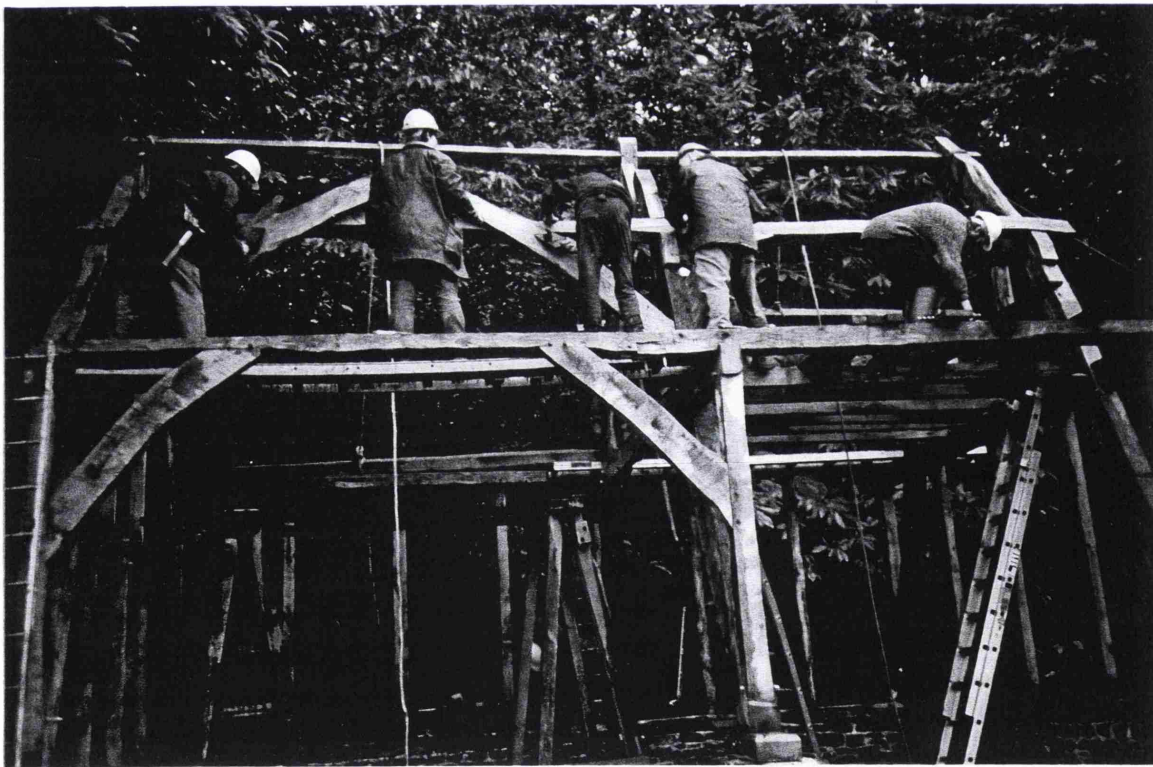
Fig. 97 A two bay cruck framed building ('Clisset barn') during assembly in 1997. The vast majority of the work was carried out using 14th century style methods and tools by hand. A) Gable frame, with hewn and see-sawn paired oak cruck blades. B) Front elevation, showing two bays and half loft to right. (Photo author).

An exception, in which this author had some involvement can be outlined below. It took very roughly 320 man/days to make and erect the basic frame work of a two bay (24'x 15'-7.30 x 5.55m), framed cruck building with a half loft. This structure is very similar to a rather solidly built c.14th century English cottage of west Midlands type (fig.97). Here the figure presented includes estimates for the medieval style replacement of a few tasks that were carried out using modern power tools such as the felling of the oak and a few sweet chestnut trees used. About 80% of the timber was converted by hand using tools and methods of the 14th century, a combination of hewing with narrow then broad axes followed in many cases by sawing using the see-saw method (Append.4). Additionally only about 1/3rd of the work force had much experience of that type of work, and the days worked were not as long as was likely in medieval times. If an allowance is included for these factors but an addition made for the roof covering, foundations

Periodic involvement in medieval and Roman style carpentry work involving hewing straight timbers with varied tools and sawing them using see-sawing, double trestle, tripod, or pit-saw methods (fig.97.). Learning something of the mysteries of medieval carpentry such as layout and joint cutting. Also experimenting with the different approaches used by Roman carpenters to make display sections of house walls closely based on the archaeological material.

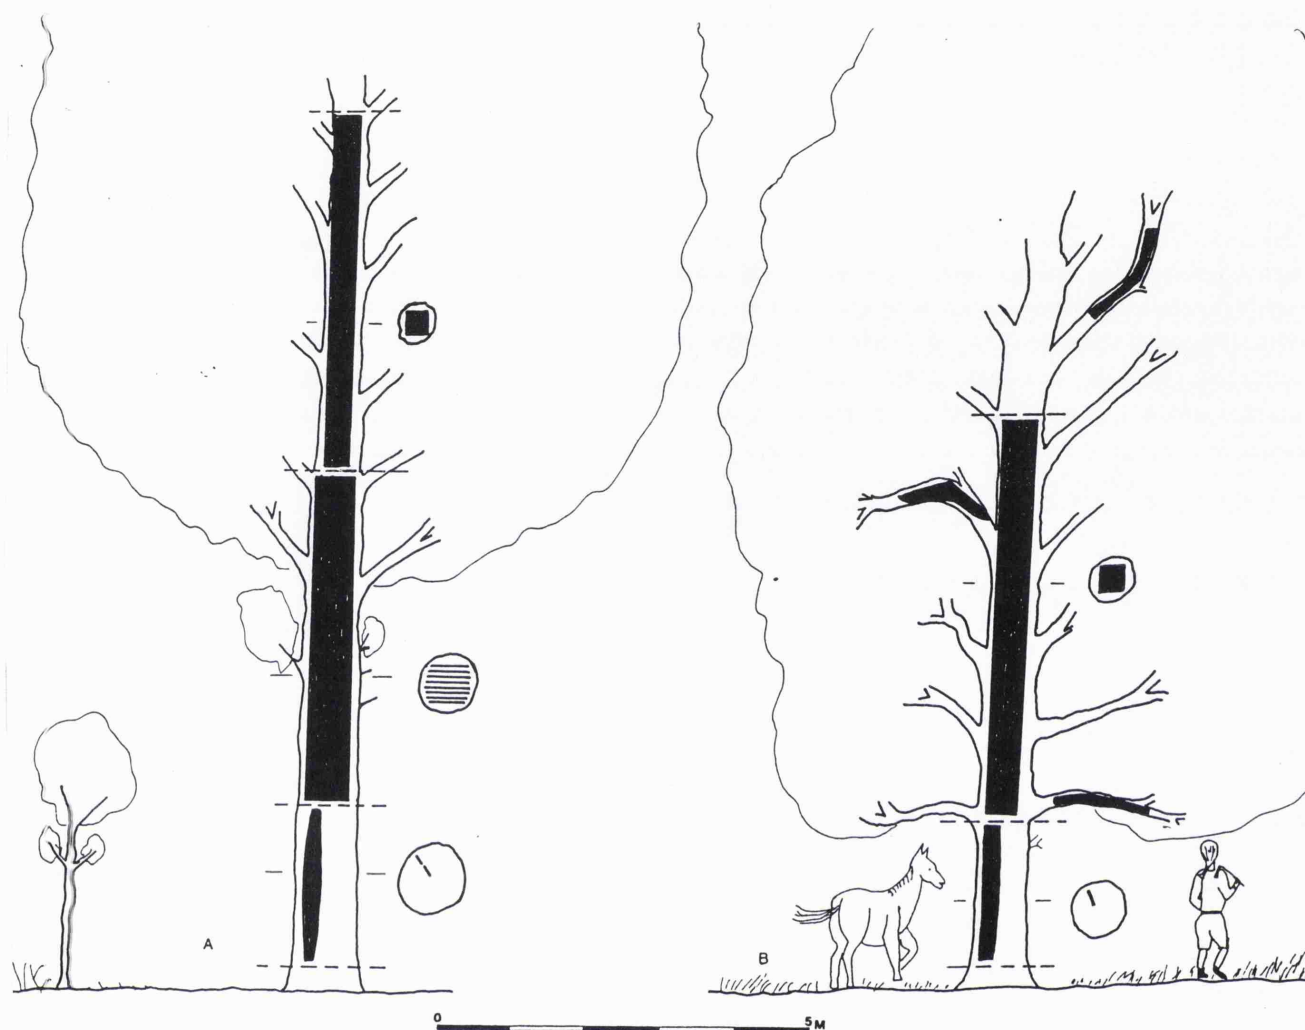
Fig. 99 The division of large oaks into several lengths in post-medieval times. A) A large oak from a French managed 'high forest' (Troncais and elsewhere) and its typical tripartite sub-division. The butt log for cleft cask staves, the 2nd log for sawn oak plank and the 3rd, for a sawn boxed heart beam. B) A hypothetical large, straight, English parkland or woodpasture oak of the 16th-17th centuries, and its possible sub-division into a butt log for the small cleft ship board of the period, and a longer 2nd length for wide sawn plank or a large hewn or sawn beam. Heavy boughs may also have provided framing timbers (crooks, and bends).
